# **Time Dilation, Technical Dilation, and Corporate Dilation**

## **TD Analysis Report**

Copyright © 2000 Michael D. O'Connor  
All Rights Reserved

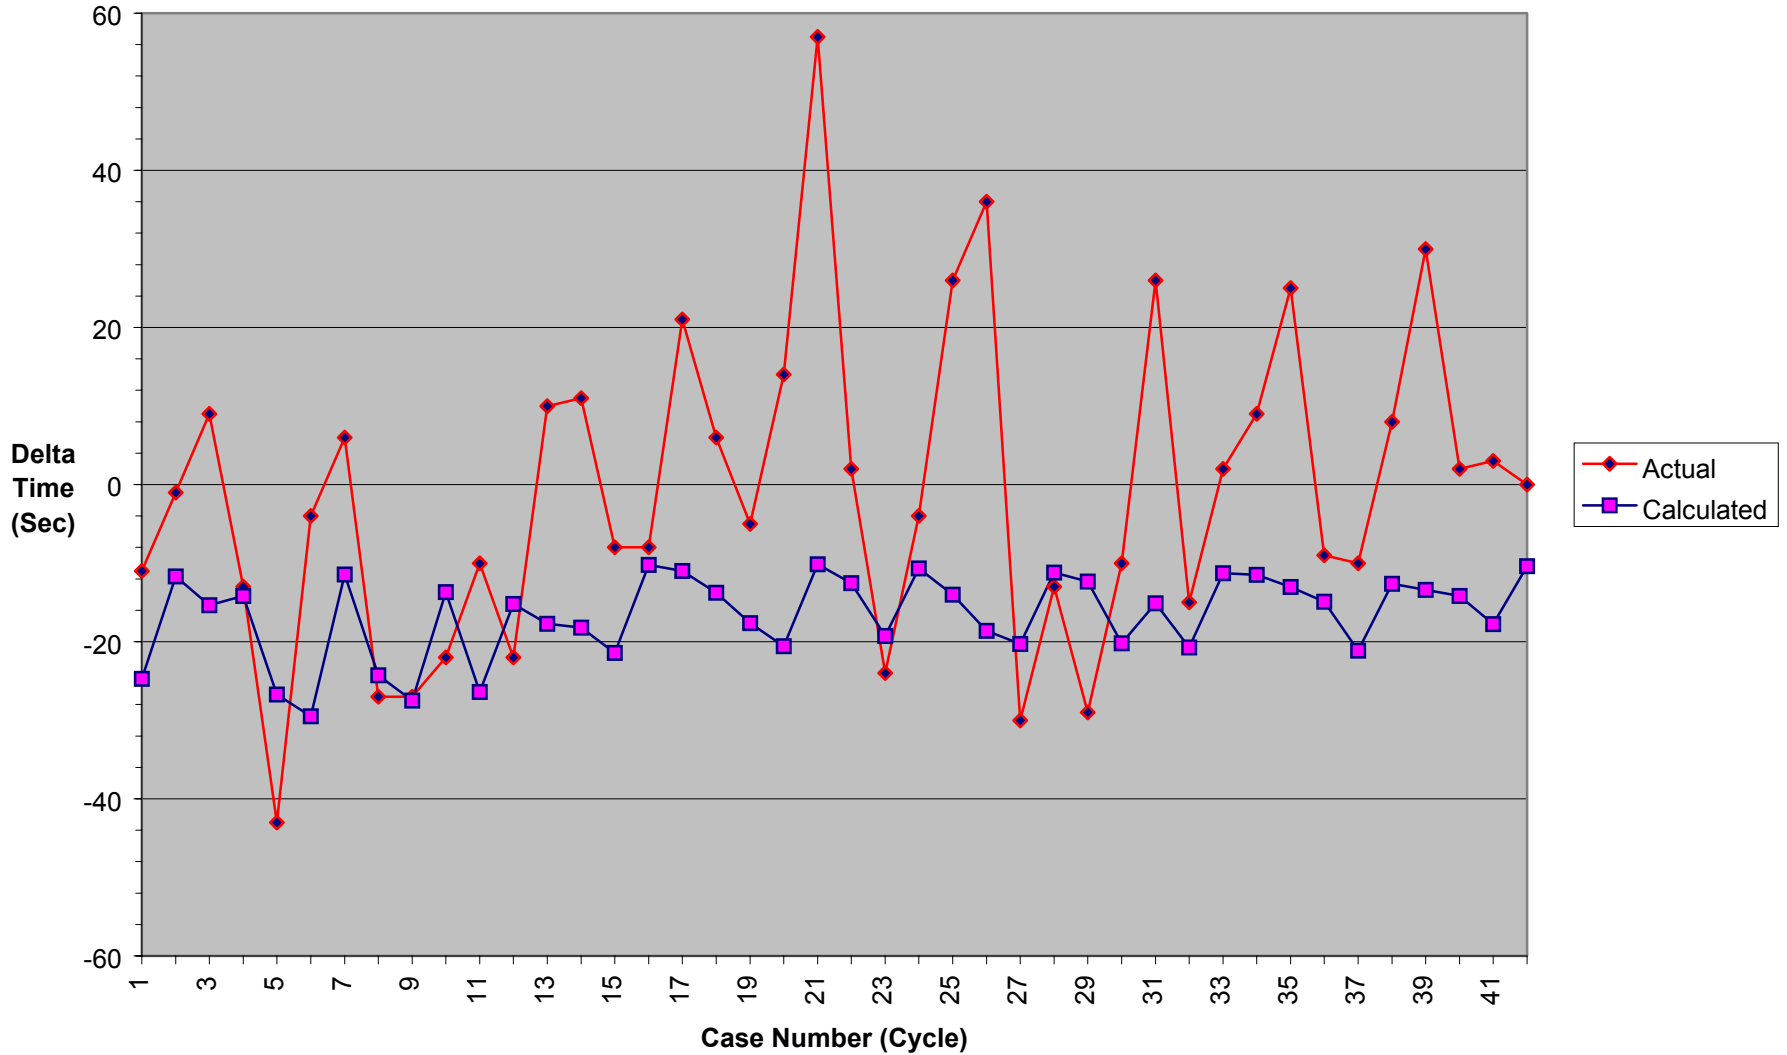
**CHART 1: Test Data Results based on wristwatch reference set to 30 seconds of time**

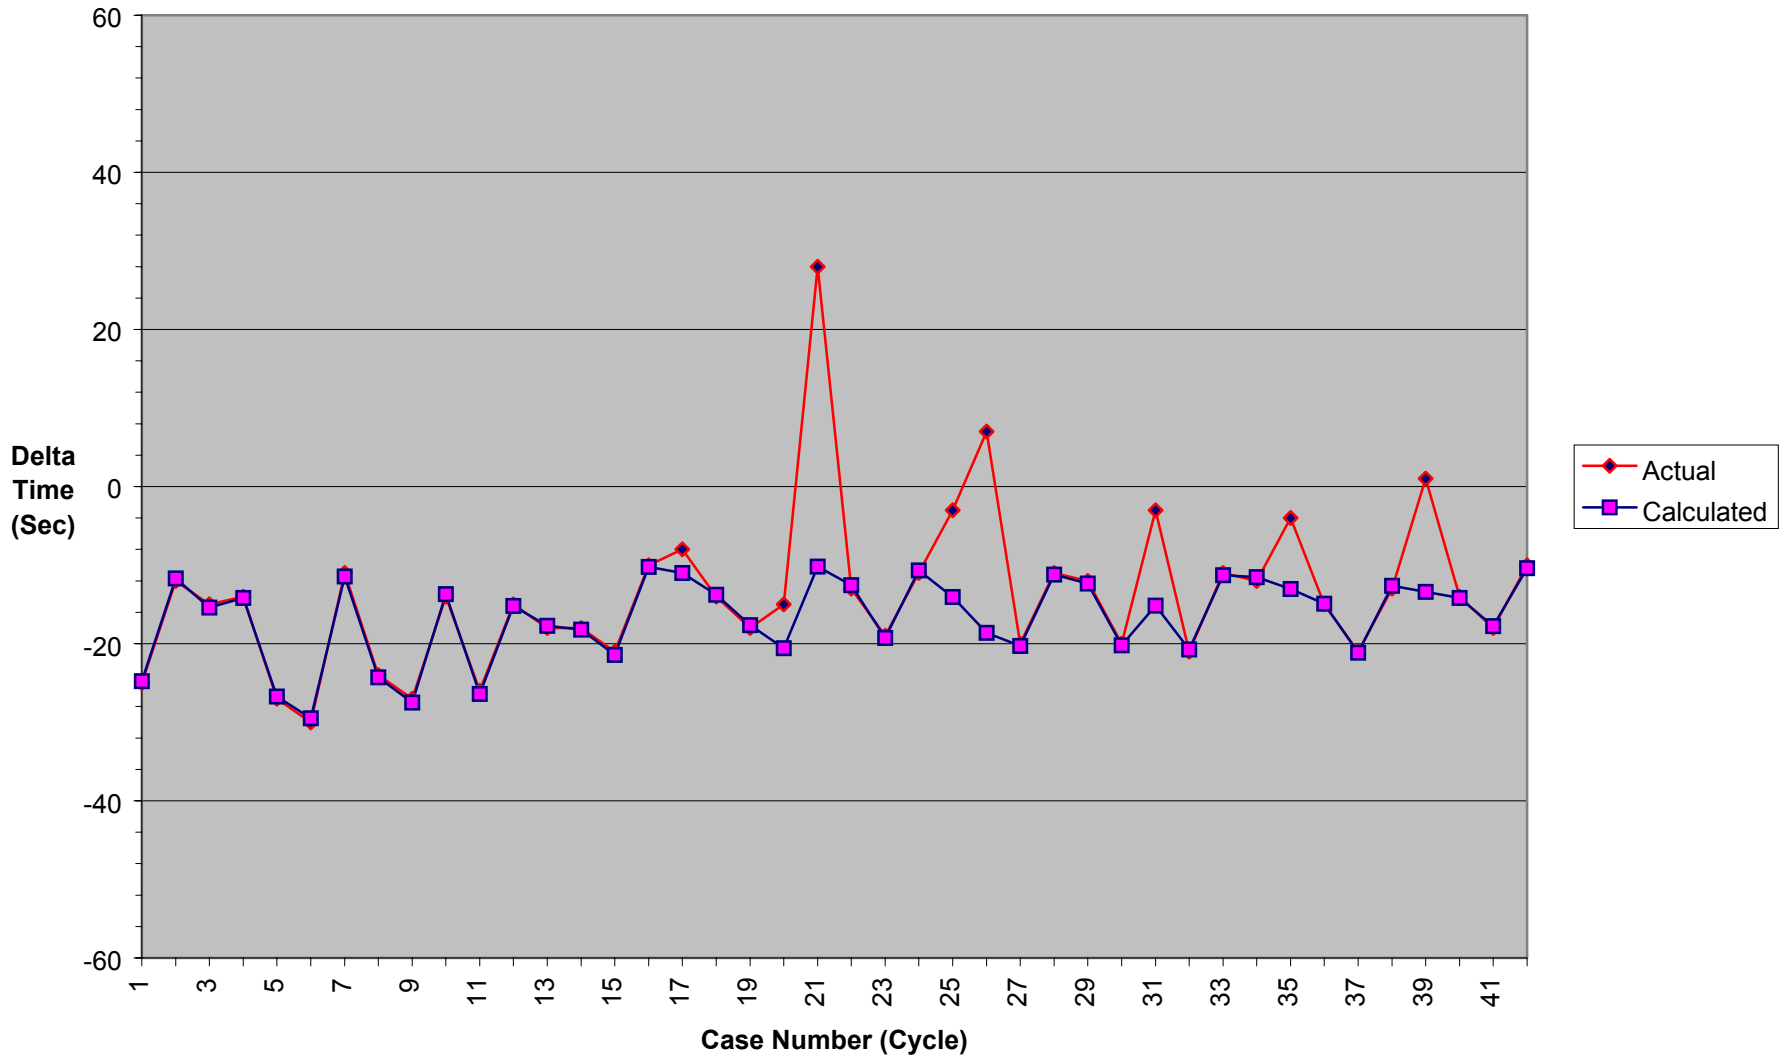
The foregoing analysis shows that all Case Numbers with advanced time anomalies fail to meet the blue plotted line regardless of the wristwatch reference seconds of time, as demonstrated by employing Figure 3 formula. This is true in both Tables 2 and 3 and respective Charts 2 and 3.

With this in mind, then, *all errant data points are positive* relative to the blue plotted line. Further, this is a consistent characteristic of the TD anomaly in this case. Theory #1 fits this scenario, while Theory #2 (I/O Delay) does not. Theory #1 guarantees consistent advanced time anomalies, while Theory #2 does not. Why? Because Theory #2 can cause the RTC address to point to some memory address whose data could result in a retrogressed time anomaly, which does not fit the characteristics described.

CHART 2: Adjusted Test Data Results based on reconstructed wristwatch seconds of time, Best Case Scenario

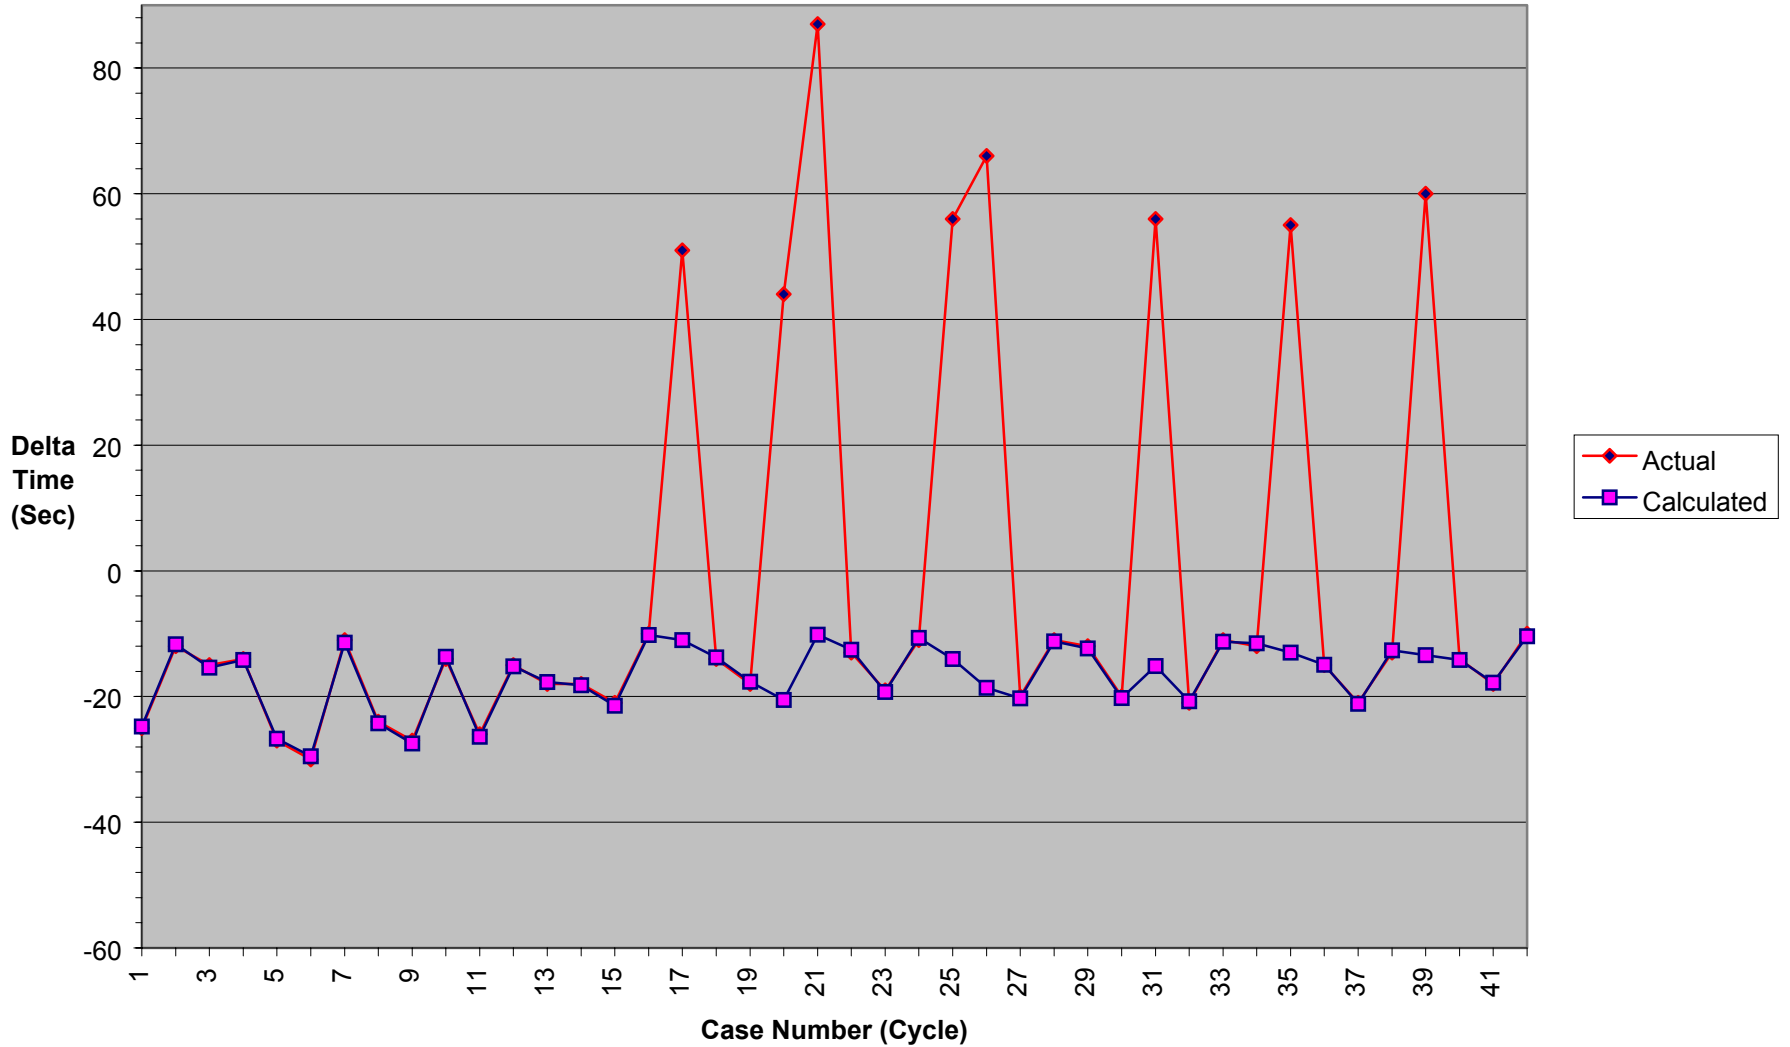
CHART 3: Adjusted Test Data Results based on reconstructed wristwatch seconds of time, Worst Case Scenario
