Time Dilation, Technical Dilation, and Corporate Dilation

TD Analysis Report

This is the finished release document. Any previous document that does not bear this notice is a draft unreleased copy, and therefore is not the finished document. This document released 15 May 2000

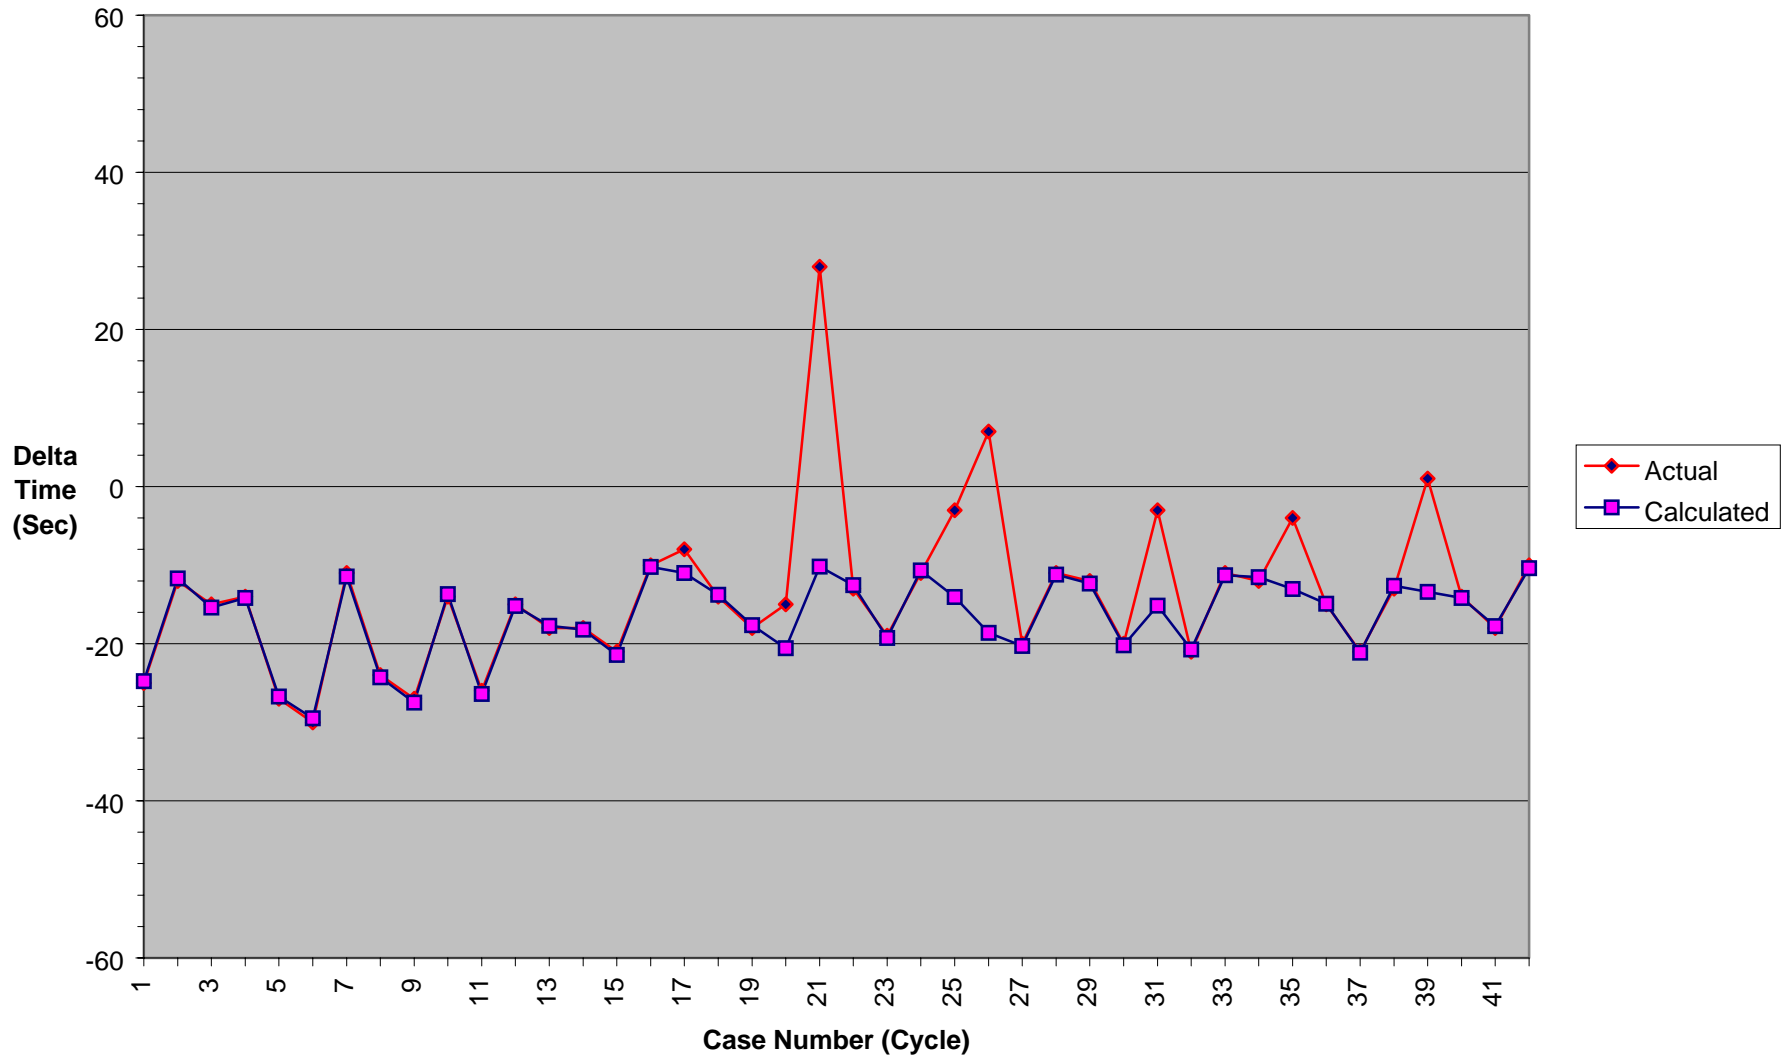
CHART 2: Adjusted Test Data Results based on reconstructed wristwatch seconds of time, Best Case Scenario

The foregoing analysis shows that all Case Numbers with advanced time anomalies fail to meet the blue plotted line regardless of the wristwatch reference seconds of time, as demonstrated by employing Figure 3 formula. This is true in both Tables 2 and 3 and respective Charts 2 and 3.

With this in mind, then, *all errant data points are positive* relative to the blue plotted line. Further, this is a consistent characteristic of the TD anomaly in this case. Theory #1 fits this scenario, while Theory #2 (I/O Delay) does not. Theory #1 guarantees consistent advanced time anomalies, while Theory #2 does not. Why? Because Theory #2 can cause the RTC address to point to some memory address whose data could result in a retrogressed time anomaly, which does not fit the characteristics described.
